A direct plug-in solid state replacement module for the 26Z5W rectifier tube of the R-390 and R-390A receiver

Dr. Kurt Schmid, DH3PJ, sigmapert@gmx.de

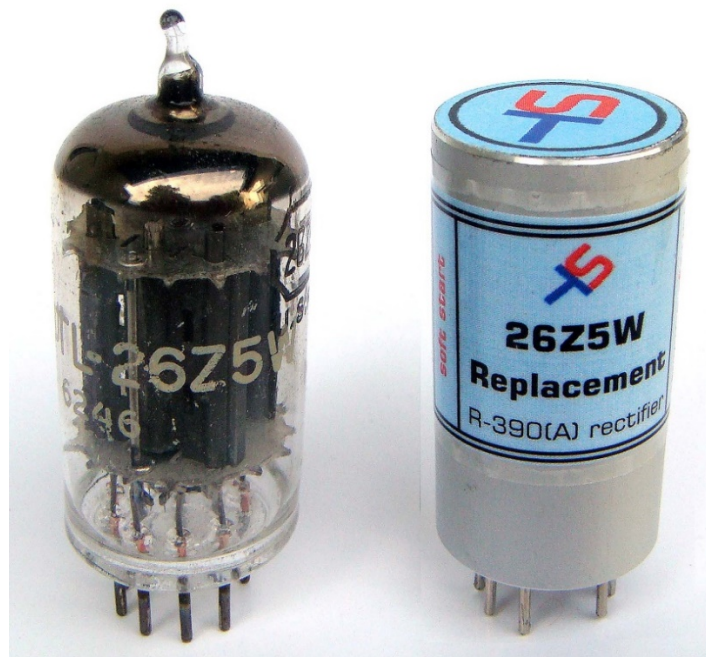
Fig. 1 26Z5W and 26Z5W replacement module side by side

In contrast to field change #6 and its hobbyist followers the new device shouldn't need any soldering work in the receiver. Finally, a full plug-in replacement for the original 26Z5W could be achieved (cf. figure 1). If you consider the plug-in module as modification the receiver can be restored to its original state by simple reinsertion of the original 26Z5Ws.

- From figure 1 it's already visually evident that the 26Z5W replacement module is more robust than the fragile original 26Z5W tube
- Significantly reduced power consumption and overall heat production of the receiver □ Longer life-time
- Less prone to rectifier-based failure in the power supply
- Eliminates the increasingly hard to find and expensive 26Z5W rectifier tubes

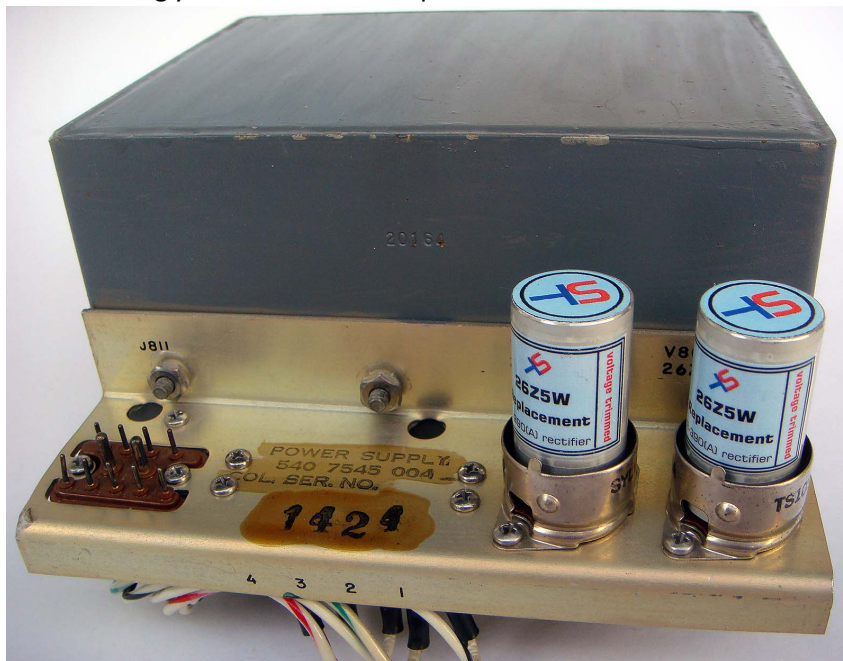
Fig. 2 Power supply chassis equipped with a pair of 26Z5W replacement modules (tube shields are no longer necessary)
