R-390A plug-in multi-section electrolytic capacitor kit

Dr. Kurt Schmid, DH3PJ, sigmapert@gmx.de

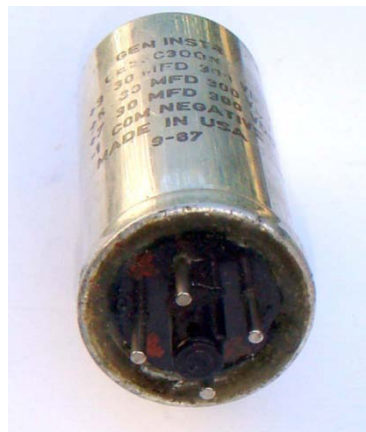
Serious restorers will consider 2 adequate recapping approaches. I have refilled lots of old R-390A electrolytic capacitor cans with brand new capacitors. This is a cumbersome and time consuming task that when performed well will result in electrically new and cosmetically acceptable capacitors.

Fig. 1 Refilled multi-section electrolytic capacitor after 14 years of flawless operation in its 'new life'

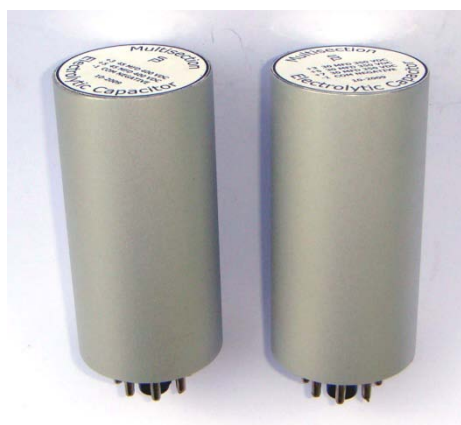
Fig. 2 Capacitor kit consisting of new C603 & C606

The two multi-section electrolytic capacitors of the R-390A are located on the audio sub-chassis. Because both are octal base plug-in types they can be replaced very easily. C603 has 3 capacitor sections (3 x 33 μ F at 300 VDC). C606 has 2 sections (2 x 45 μ F at 300 VDC). Especially the operating voltage of C606 seems to be a bit underrated.

Whereas the capacitances of the capacitor kit are the same as the original values the operating voltage was increased from 300 VDC to 400 VDC. Temperature is rated at 105°C. Because the mechanical dimensions of the aluminum housing are identical to the original (e.g. 1-3/8" OD) the original clamps that securely held the capacitors in their octal sockets fit nicely. The hard anodized aluminum housings of the new capacitors are more scratch resistant than the original blank aluminum cans.

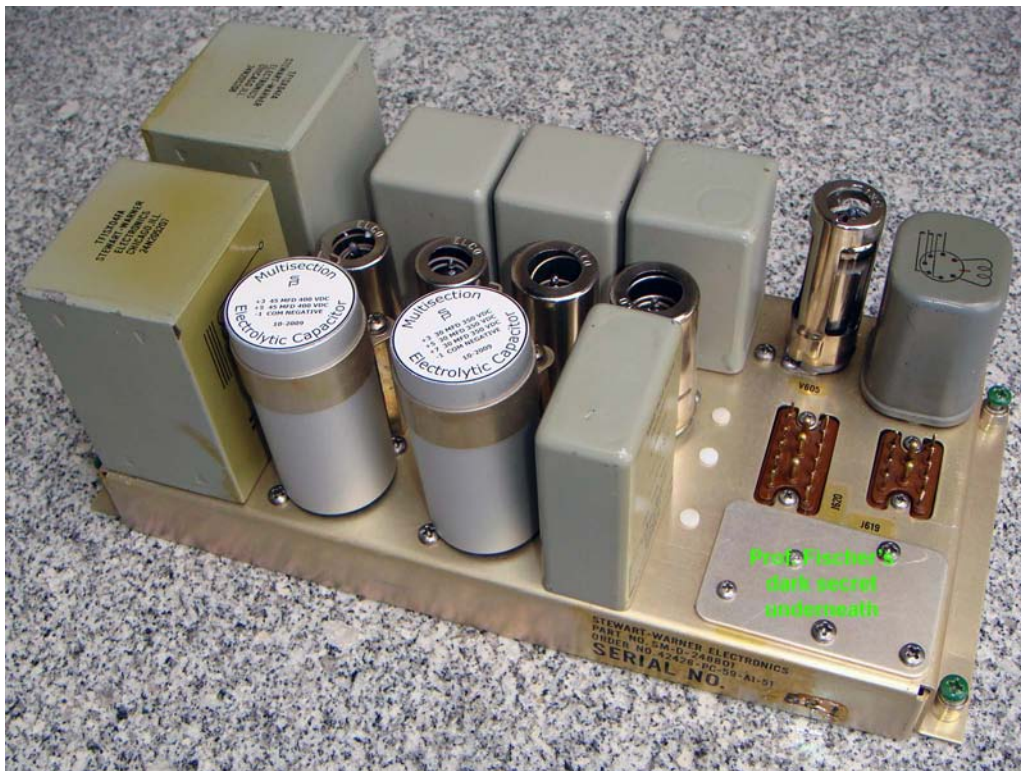
Fig. 3 Stewart-Warner audio module recapped with new electrolytic capacitors C603 & C606

For the totally uninformed R-390A expert, the green writing in figure 3 refers to the squelch facility well recherché and beautifully described by my friend Johannes (see [Y2K-R-rA manual](#)).

Recapping the audio sub-chassis with high quality electrolytic capacitors is a good prerequisite for your R-390A to operate for another 50 years. Don't forget also to replace the infamous tubular electrolytic capacitor C609 (8 μ F/30 VDC) located underneath the chassis with a hermetically sealed military-grade one.

Attention: Be careful when inserting but especially when retracting the capacitor from the octal socket not to brake off the keyway of the base.
